**FIELD OPERATIONS AND OCEAN-BOTTOM
SEISMOGRAPH PERFORMANCE AND EVALUATION
KURILE ISLANDS EXPERIMENT**

Special Report No. 1

OCEAN-BOTTOM SEISMOGRAPHIC EXPERIMENTS

TEXAS INSTRUMENTS INCORPORATED
Science Services Division
P.O. Box 5621
Dallas, Texas 75222

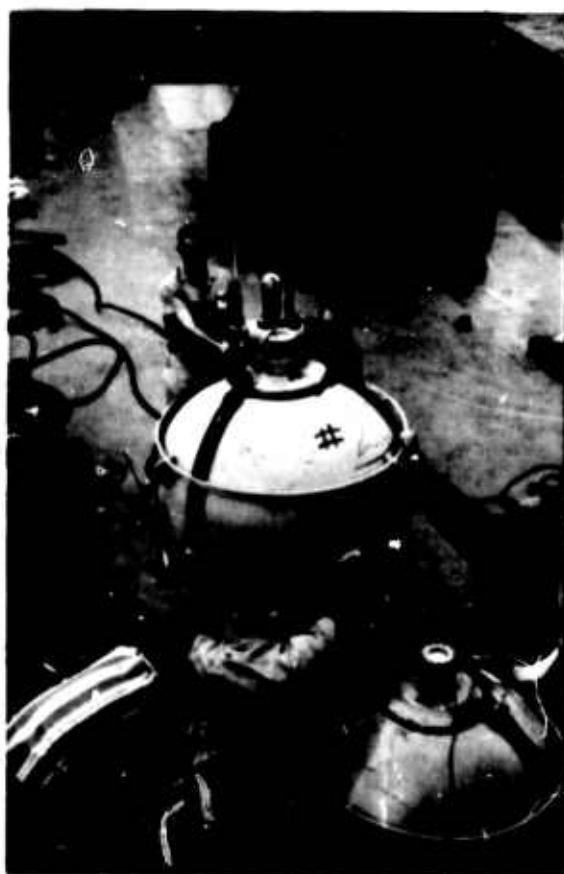
Figure 2. Track-Mounted Crane

The M/V Calcasieu, owned by General Marine Transport of Santa Barbara, was used for this operation (Figure 1). A track-mounted mobile crane was placed aboard to facilitate launching and retrieval of O. B. Seis units (Figure 2). Also installed on deck and located where the cat-head could be used to retrieve the anchors was the Nova winch. The only other necessary equipment on board was the sonar transmitter cabinet and the sonar transducer.

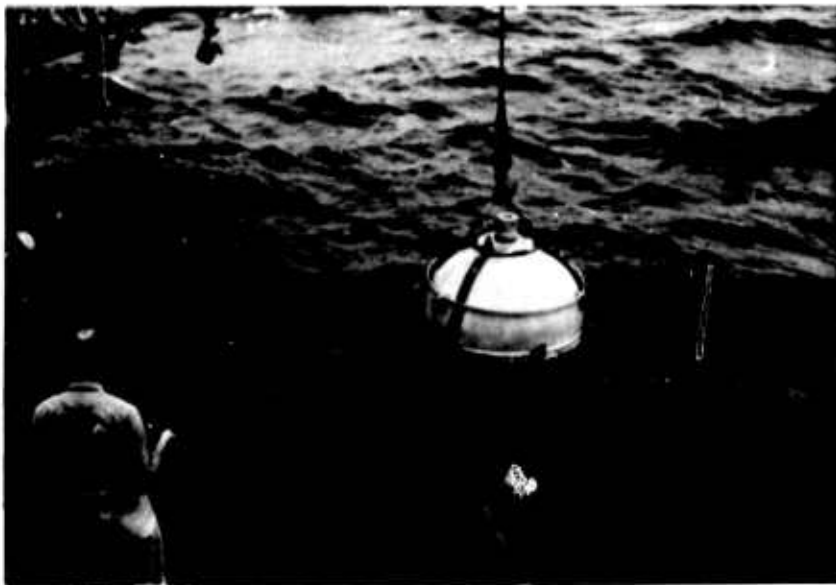
Figure 3. Rope and Float Tied to Anchor

- Check out, start, and seal each unit in the warehouse
- Transfer each unit to the deck of the Calcasieu
- Proceed to the drop site - 80 to 200 feet depth
- Tie rope and float to the anchor (Figure 3)

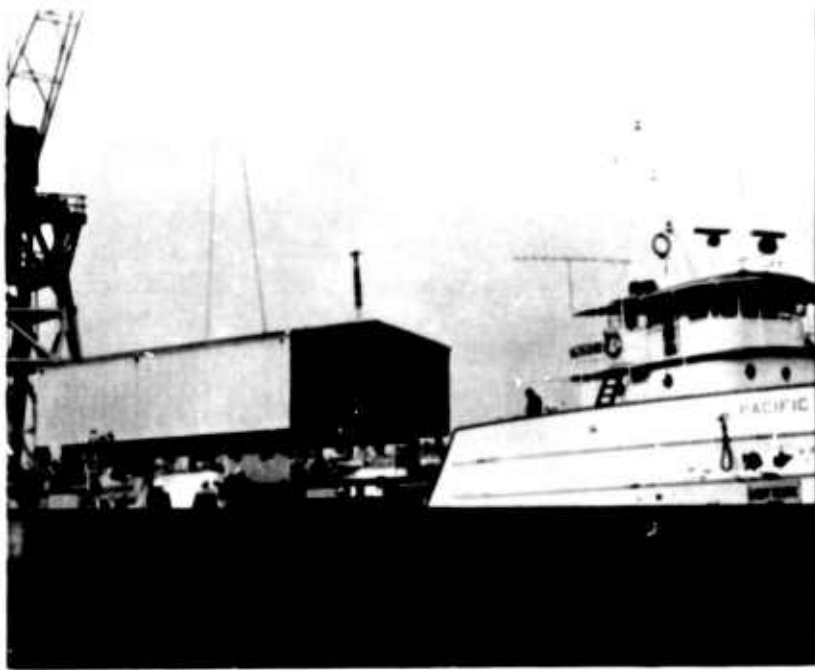
Figure 6. Instrument House (Being Off-Loaded)

Prefabricated material purchased from American Buildings was used to construct the two instrument houses on deck (Figure 6). They were constructed so that they could be cut loose and removed from the deck of the ship after completion of the operations. The floor level was about 2 feet above deck level in order to keep out the deck wash. Tracks were welded to the floor to facilitate placement and movement of the O. B. Seis units. Each house was equipped with a turn-table on slides to enable the O. B. Seis units to be moved in and out of the house (Figure 7). The larger house could accommodate 18 O. B. Seis units and the smaller house 5 units. Overhead hand-operated chain hoists on traveling blocks were mounted where they could be used to lift covers wherever necessary. To each house was added storage space, work benches, lights, power outlets, and electric heaters.

- Adding a 45 foot x 25 foot instrument house to the M/V Pacific Seal
- Adding a 25 foot x 15 foot instrument house to the M/V Campeche Seal
- Mounting a heavy duty hydraulic crane on the stern of each vessel
- Installing an Ocean Sonics, Inc. model GDR-T fathometer in each vessel
- Mounting various antennas for receiving WWV, radio beacon direction finder, D-X Navigator, and other communication antennas for direct contact with military channels in Japan
- Installing D-X Navigator (Loran A and C receiver) equipment aboard both vessels
- Installing Omega navigation system with antenna aboard the M/V Pacific Seal
- Installing special handling gear on the M/V Campeche Seal, e.g., the launch slide for the calibration shots

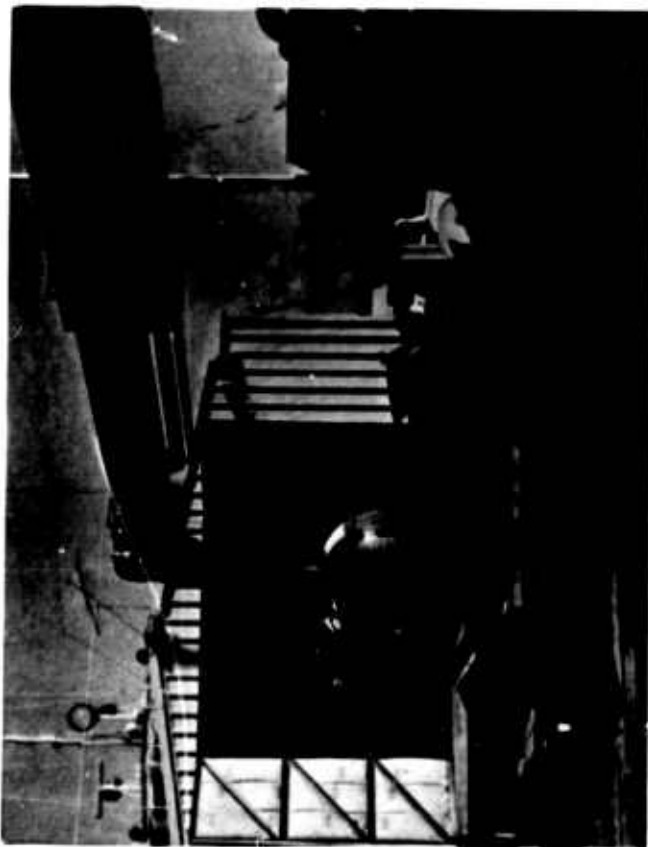
Figure 8. Hydraulic Crane

Hydraulic cranes were mounted on the starboard stern quarter of the ships so that they could reach out over either the stern or the starboard side of the ship (Figure 8). When extended, the boom could reach out 35 feet. The wheels of the cranes were removed and the units were welded to the deck. On each, a cat-head, which was used to move the turn table in and out of the house, was attached to the left front hub. Cranes used were a Galion Model C-110 on the M/V Pacific Seal, and an A-W Model 410 on the M/V Campeche Seal.

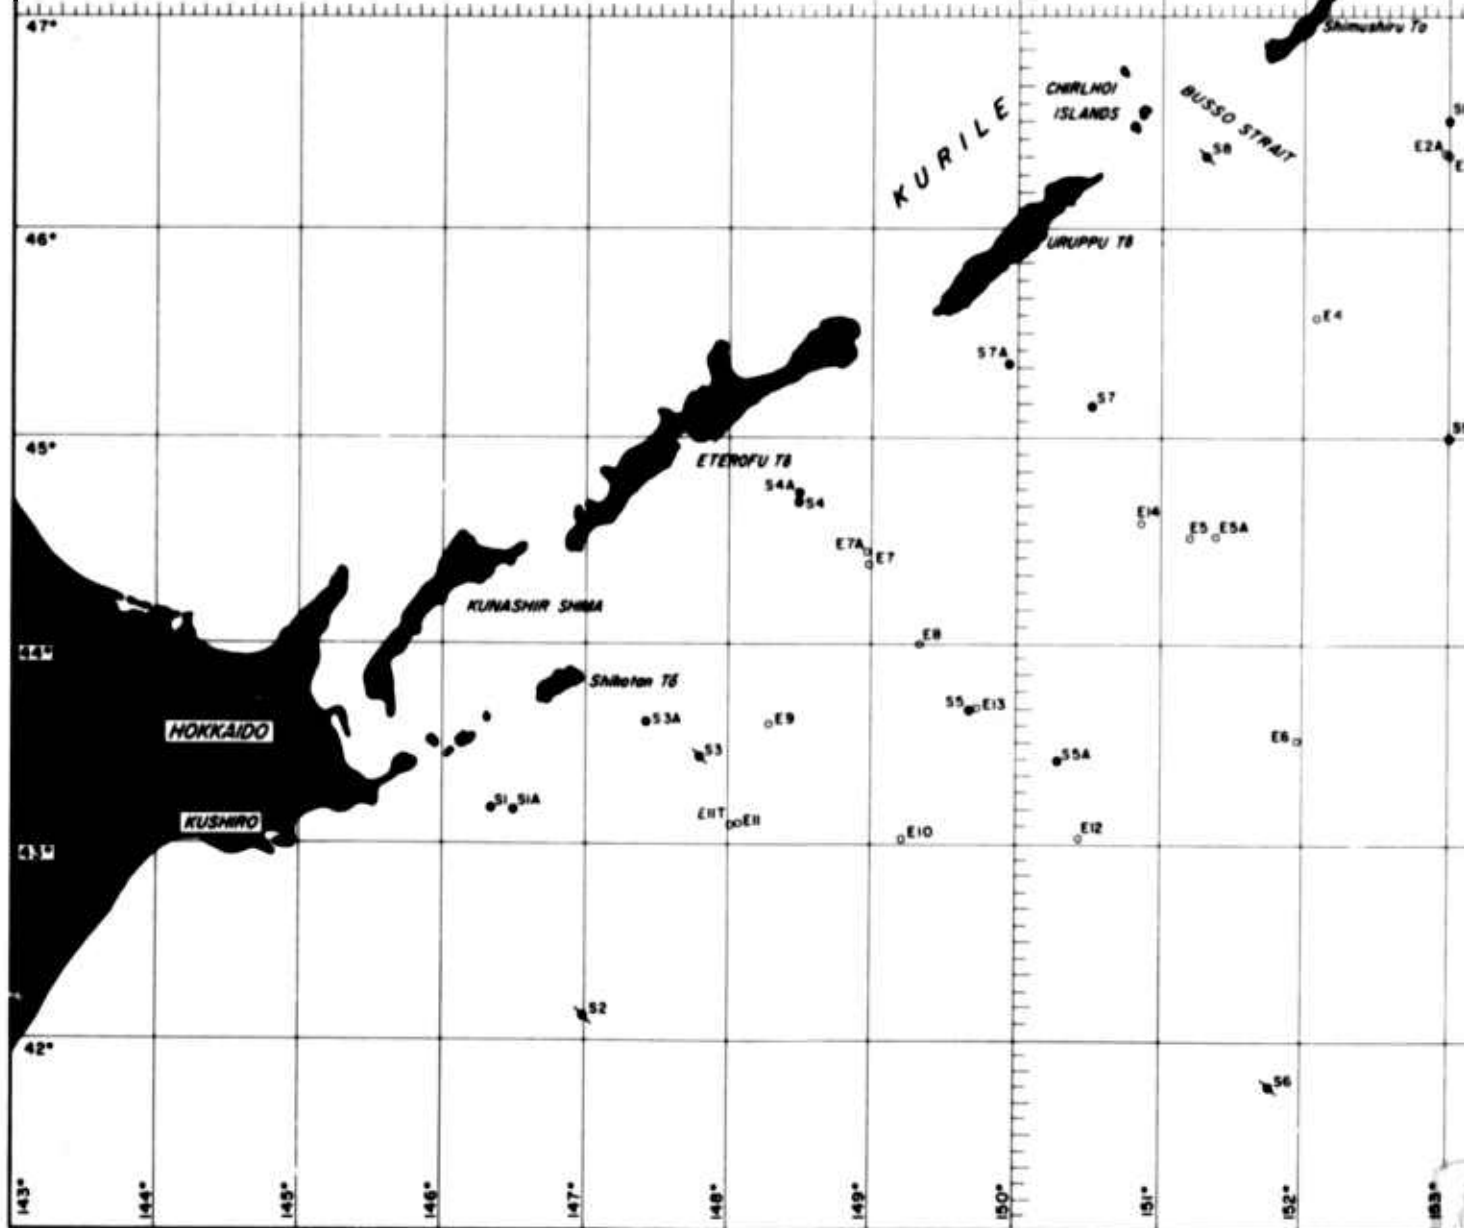
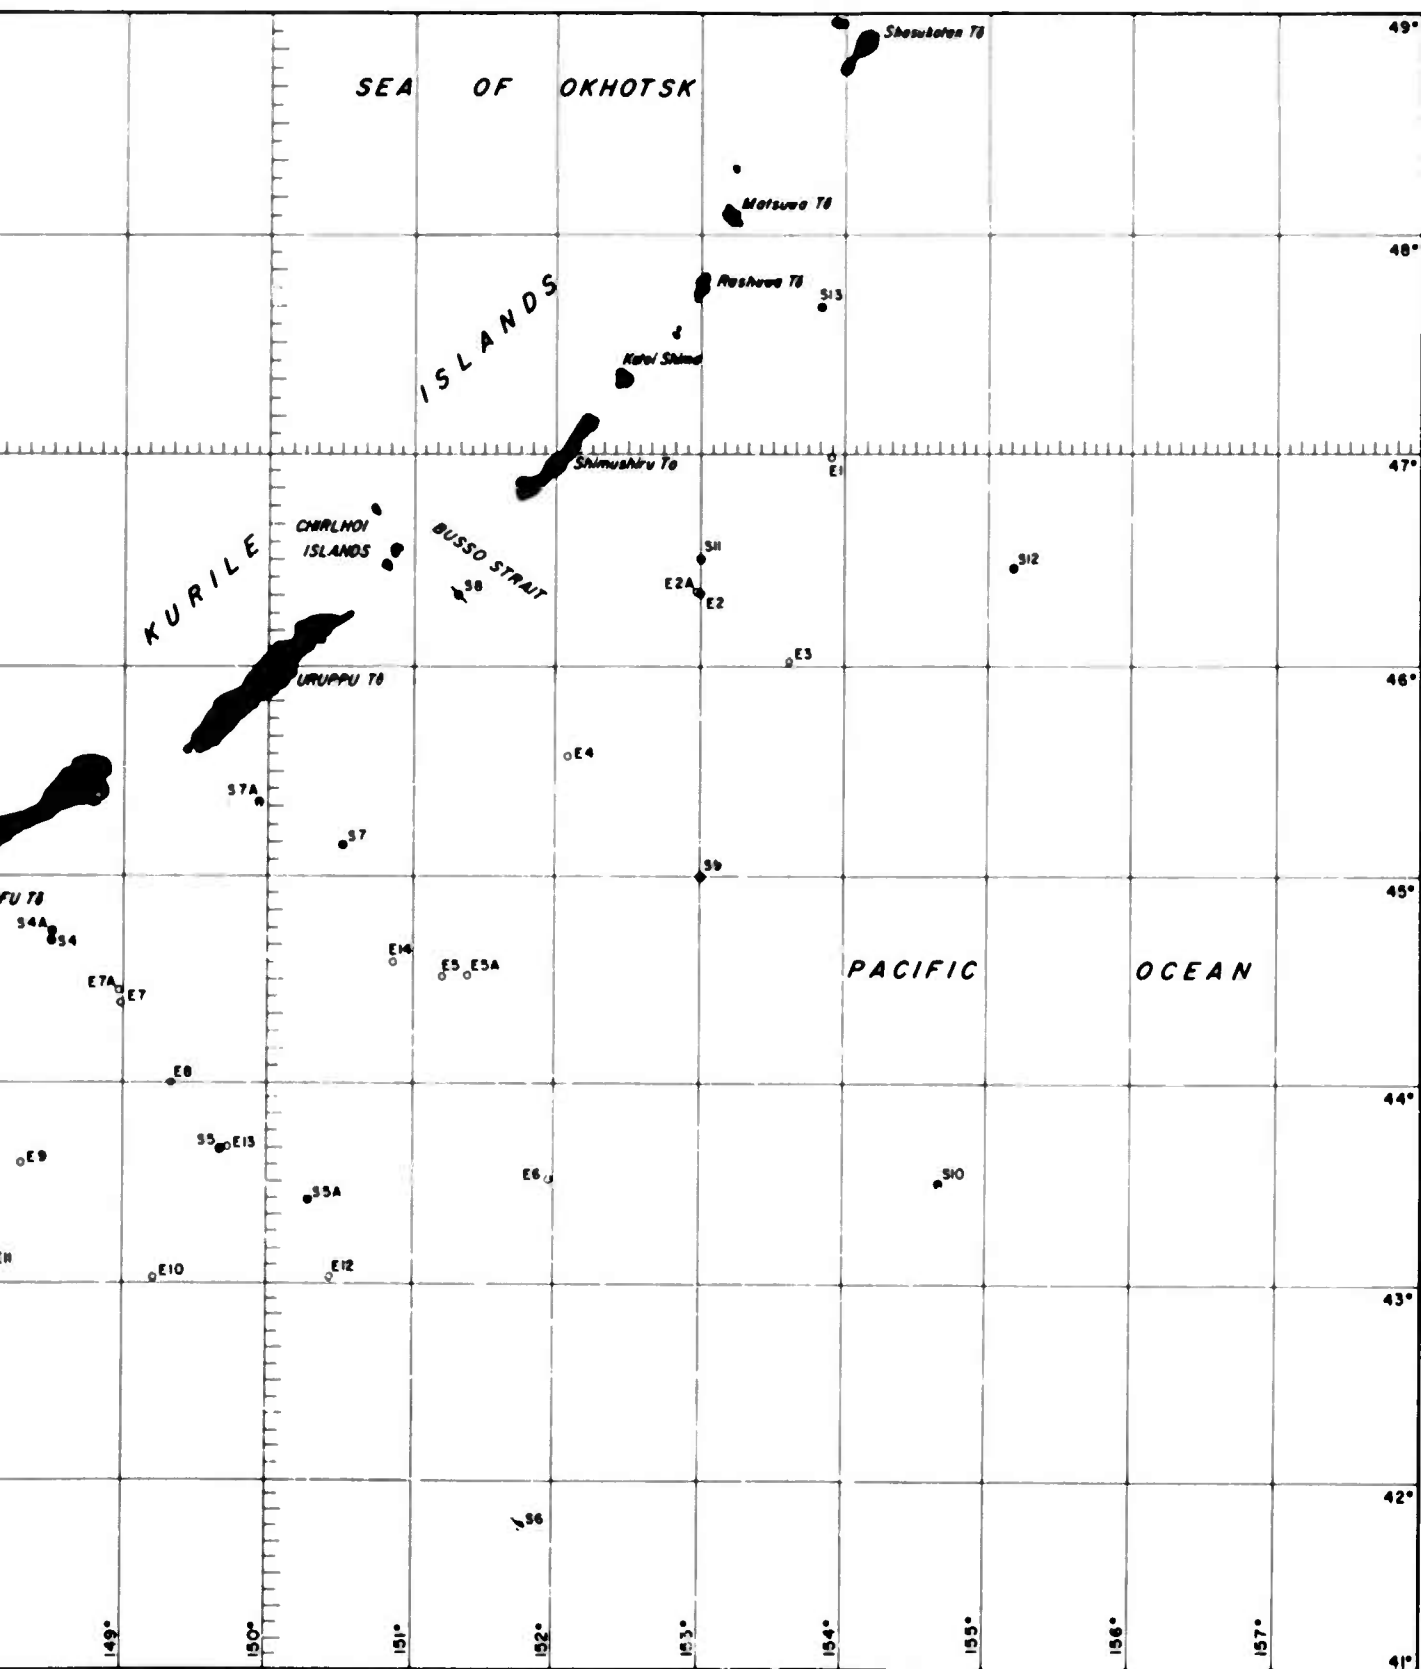
Figure 9. Site of Operations
III-7/8

On 21 October 1966, both ships left Kushiro enroute to the operations site. Figure 9 shows the site of operations.

EVENT AND SYSTEM LOCATION CHART KURILE ISLANDS NORTH PACIFIC OCEAN

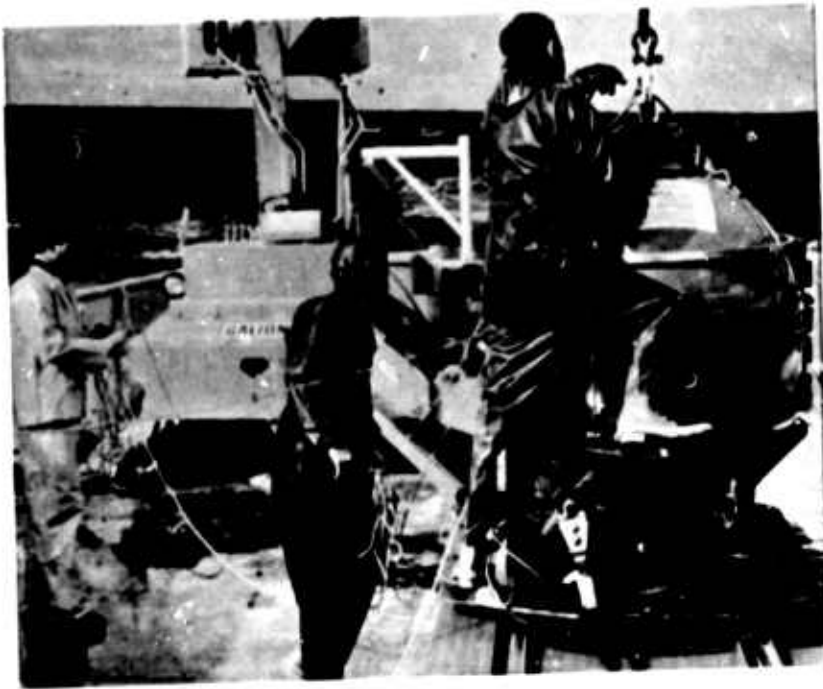
Figure 11. O. B. Seis Ready for Drop

See Appendix A. JJY time was immediately written on the data sheet. After recording JJY for 10 minutes or longer, as necessary to record some good signal, another visual check was made of all switches, plug-ins, and tape travel before putting the cover on the unit. The unit was then sealed, partially evacuated, and the beacon light, antenna, and bale were secured in place. The unit was then moved to a position outside the house where it could be reached by the crane (Figure 11).

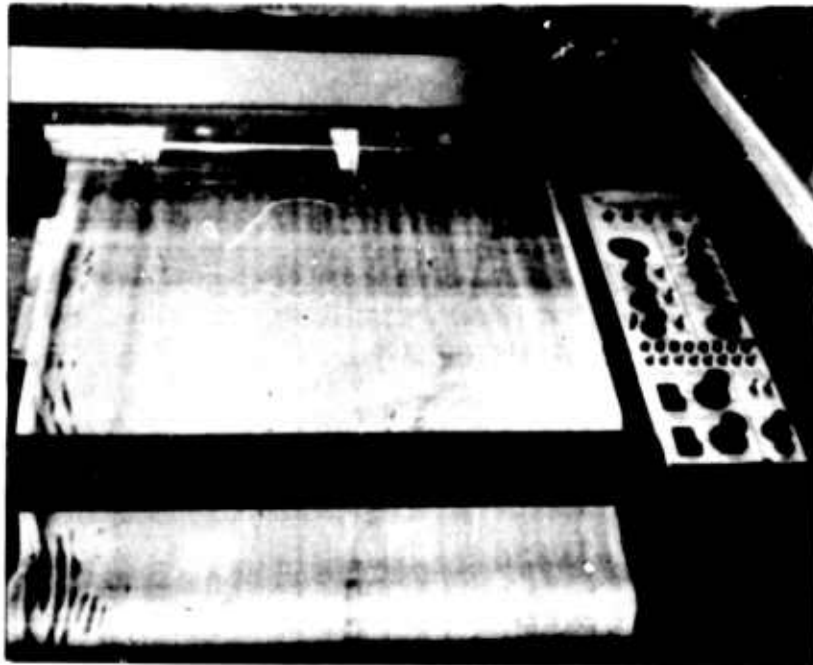
Figure 14. GDR-T Precision Sonar

When operating properly, the GDR-T was an excellent echo sounder. However, break-down and maintenance time required to keep the equipment operable must be considered excessive. Most of the troubles were traced to the printed circuit boards, and consisted of both component failures and some poor workmanship in the soldering and assembly of the boards. These problems have been made known to the manufacturer and he requested that both systems be sent to the factory for a complete overhaul and checkout.

The unit aboard the M/V Pacific Seal would only operate to depths of a few hundred fathoms. During the last month of operations, this unit was shut down and parts removed to supply the necessary spares for the other unit.
